SANITARY SURVEY FORM - INVENTORY

PWSID 0400260
Date of survey: 3/14 & 19/2018

SYSTEM NAME Hopi Cultural Center

SURVEYOR NAME – **Dan L. Fraser, P.E. & JanDee May of Sleeping Giant Environmental Consultants, LLP**

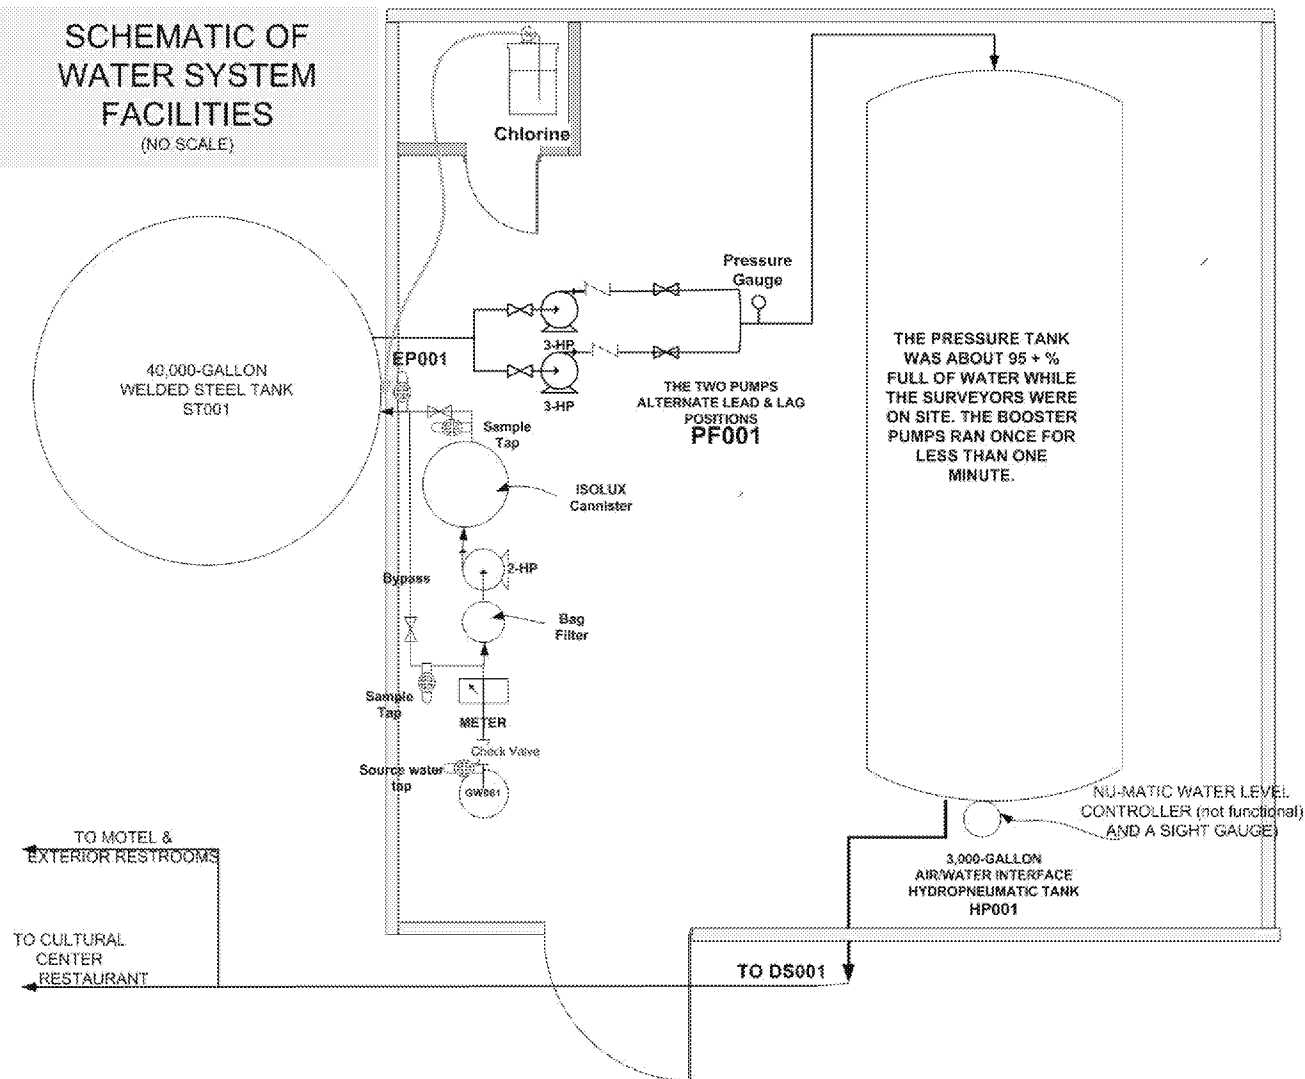
Schematic of Installation:

Comments: The pressure tank should be taken out of service and inspected to make sure it does not present a serious safety risk to the operators. The tank is nearly waterlogged.

It should be noted that the chlorine is injected post-arsenic treatment. SGEC recommends injection as early as possible pre-arsenic treatment to oxidize dissolved arsenic in the well water.

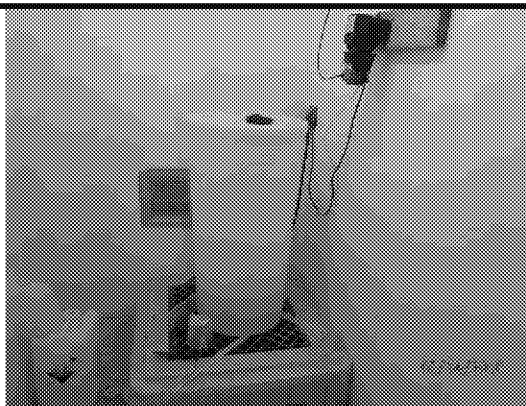
Measured chlorine residual: 0.38 mg/L Location(s): Hotel – The chlorine solution is diluted to 1.8 percent.

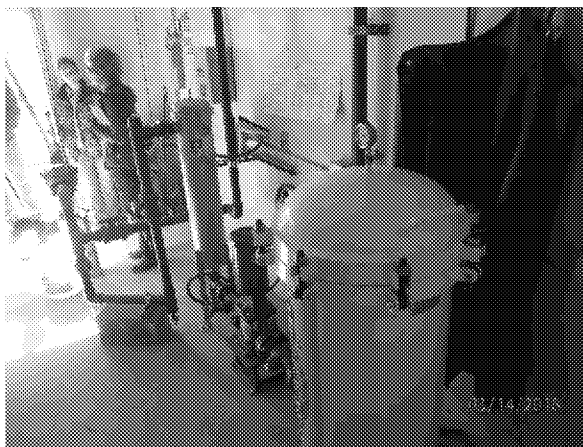
The chlorine solution is injected by a 5.0 GPD Stenner pump.

ISOLUX arsenic removal system.

Comments: SGEC recommends that the chlorine injection point be moved to a point ahead of the arsenic removal system to oxidize the dissolved arsenic.

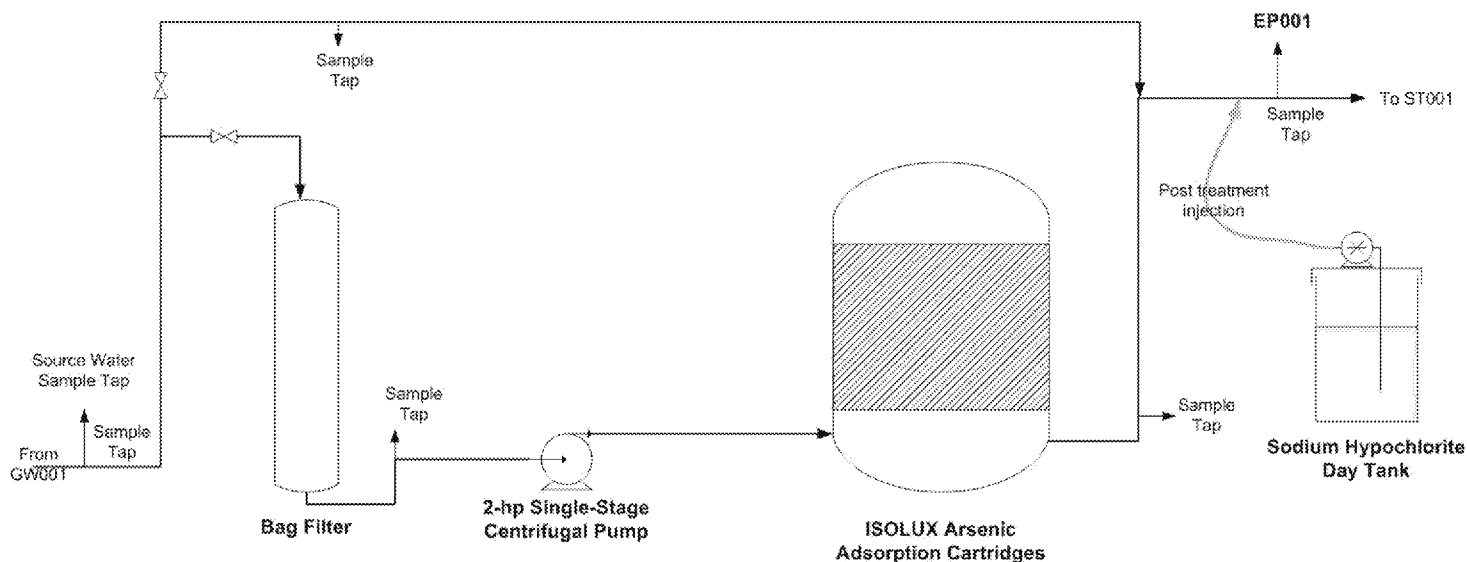
Schematic of TP001
(no scale)

As the treatment plant is currently configured, the water is chlorinated after it passes through the bag filter, ISOLUX unit and bypass line. This does not make sense to SGEC as pre-chlorination may be necessary to ensure oxidation of the dissolved arsenic in this deep well. If pre-chlorination is initiated, there will not be very much contact time to ensure oxidation occurs before it passes through the adsorptive media.

The water is currently bypassing the bag filter and ISOLUX units because of air problems in the well water. Therefore, the PWS is almost certain to be violating the MCL for arsenic (SGEC does not have monitoring reports to support this assumption).

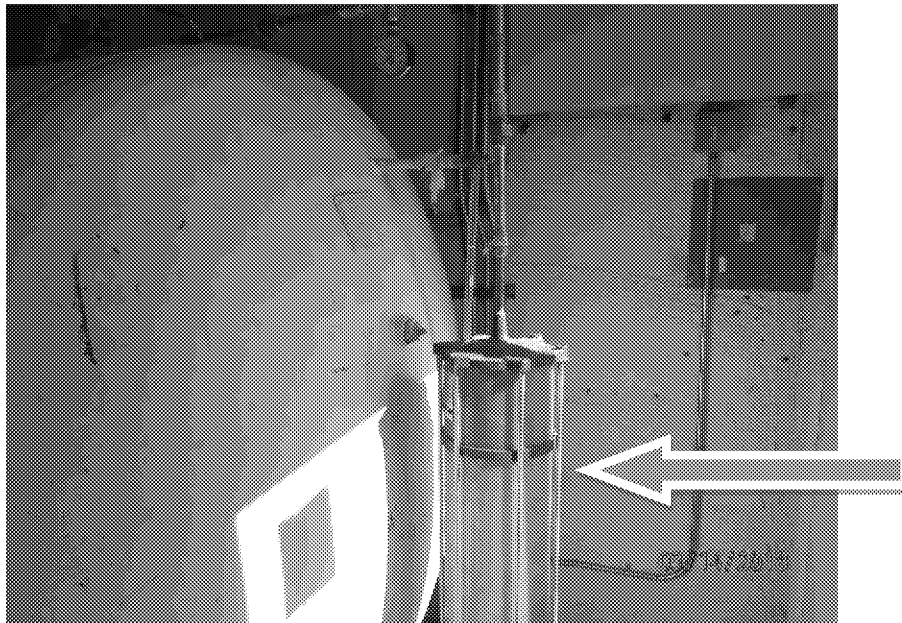
Comments: The Nu-Matic controller is not working and air has to be introduced with a compressor.

The Nu-Matic unit is designed to keep the appropriate amount of air in the tank. It is not working so the operator must periodically bring in an air compressor to provide supplementary air. It currently needs air to be added.

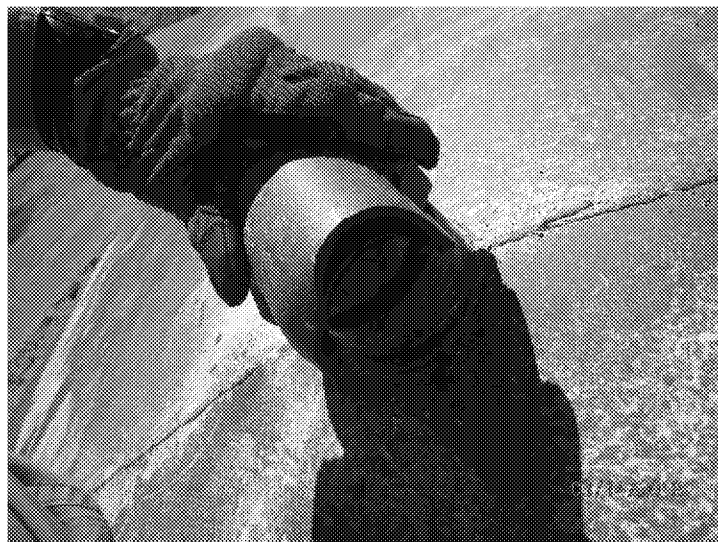
Comments: The tank has no provisions for fall protection. The vent is too small and broken. The hatch has a bolted in place flanged cover making viewing of the interior very difficult.

One-half of the Tee-shaped vent is broken off leaving the interior of the tank vulnerable to dust, insects and small birds.

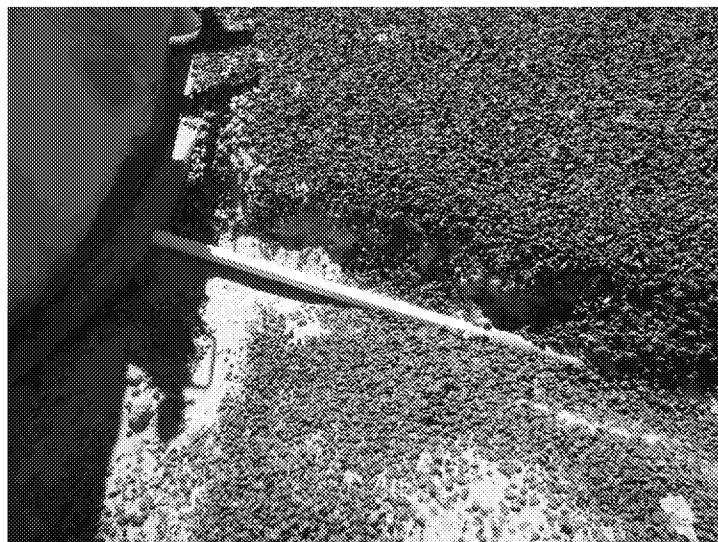
Comments: The tank needs to be rehabbed or replaced. It has had a leak in the recent past.

This is the way the operator has directed the leakage away from the ring foundation. The leak has been repaired but how long the repairs will last is questionable.
